EVALUATING DAMAGE ASSESSMENT OF BREACHES ALONG THE EMBANKMENTS OF INDUS RIVER DURING FLOOD 2010 USING REMOTE SENSING TECHNIQUES

R. Ahmad^{a,*}, Daniyal^a

^a Space Technology Applications Directorate, Space Application Research Wing, SUPARCO HQs, Karachi, Pakistan, iraheelahmad@gmail.com, ddaniyal@yahoo.com

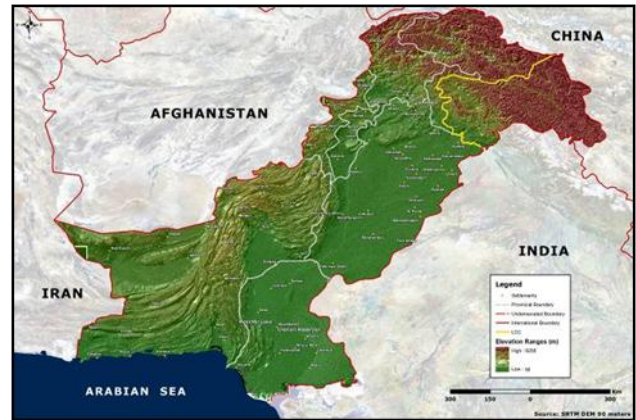
Figure 1. DEM showing elevation perspective of Pakistan

Vulnerable areas which were susceptible to breaches were mapped using slope, sinks and flow direction maps of the areas. The sink areas (low-lying with respect to neighboring areas) were potentially more prone to floods due to gradient differences. The gradient differences provided the natural routes for flood water to rush through breaches. Fig. 1 shows the Digital Elevation Model (DEM) of Pakistan depicting the general trend of elevations.

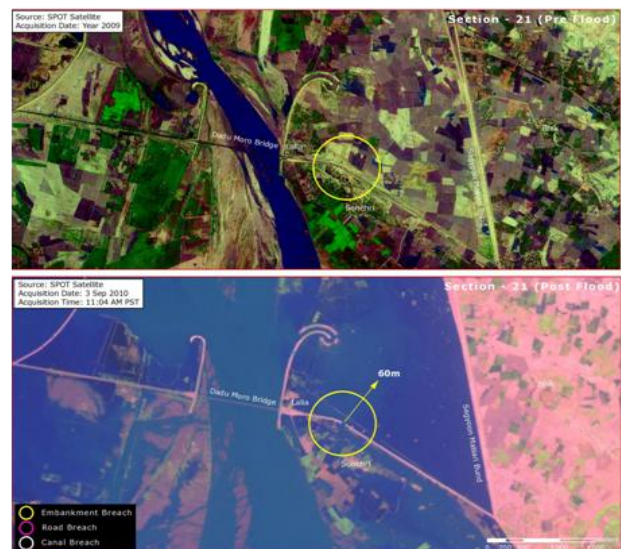
Few breaches were not destructive due to presence of second defense line of embankments. Destruction of infrastructure created major hurdle in evacuation and rehabilitation especially due to damaged roads. Fig. 4 shows a 60 meter breach which occurred on Dadu-Moro road embankment on Indus river (linking National Highway N-5 to Indus Highway N-55) produced a major infrastructure loss as it disconnected the residents of left and right bank of Indus river in the area.

Figure 4. . Dadu-Moro Road Breach, Sindh

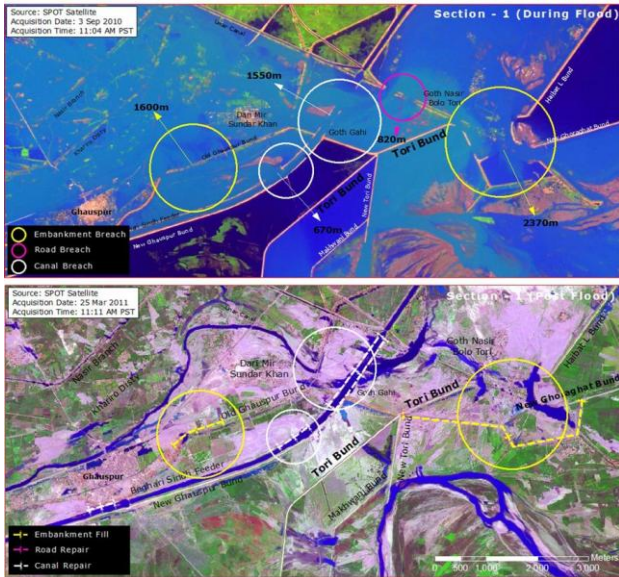
The Tori breach in Sindh and LMB in Punjab were filled on urgent basis since these breaches caused major destruction over large areas. Fig. 5 shows the rehabilitation of Tori embankment breach.

Figure 5. Rehabilitation of Tori Breach, Sindh

A new parallel embankment was constructed instead of filling the breach at Tori. Other consequent breaches of Tori (Old Ghauspur and the embankments of Beghari Sindh Feeder) were also rehabilitated as shown in Fig. 5. Ghauspur town was badly affected and water overtopped the Indus highway which passed through the town.

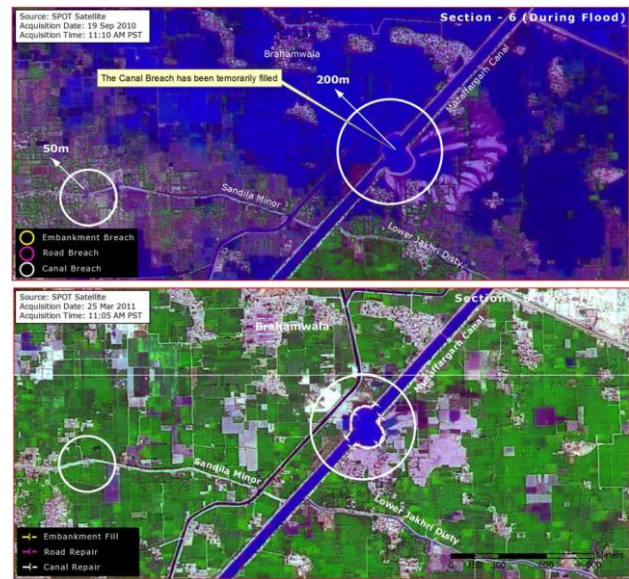
Figure 7. Filling of Muzaffargarh Canal Breach, Punjab

Some of the breaches which were repaired on priority basis were not rehabilitated up to standards such that the width of protective embankments had not been maintained whereas some of the breaches were temporarily filled by creating a curved structure. Such filling have been considered as partially repaired breaches. Fig. 7 shows partial filling of Muzaffargarh canal breach, district Muzaffargarh in Punjab.
